MAST SUPPORT FIX C14

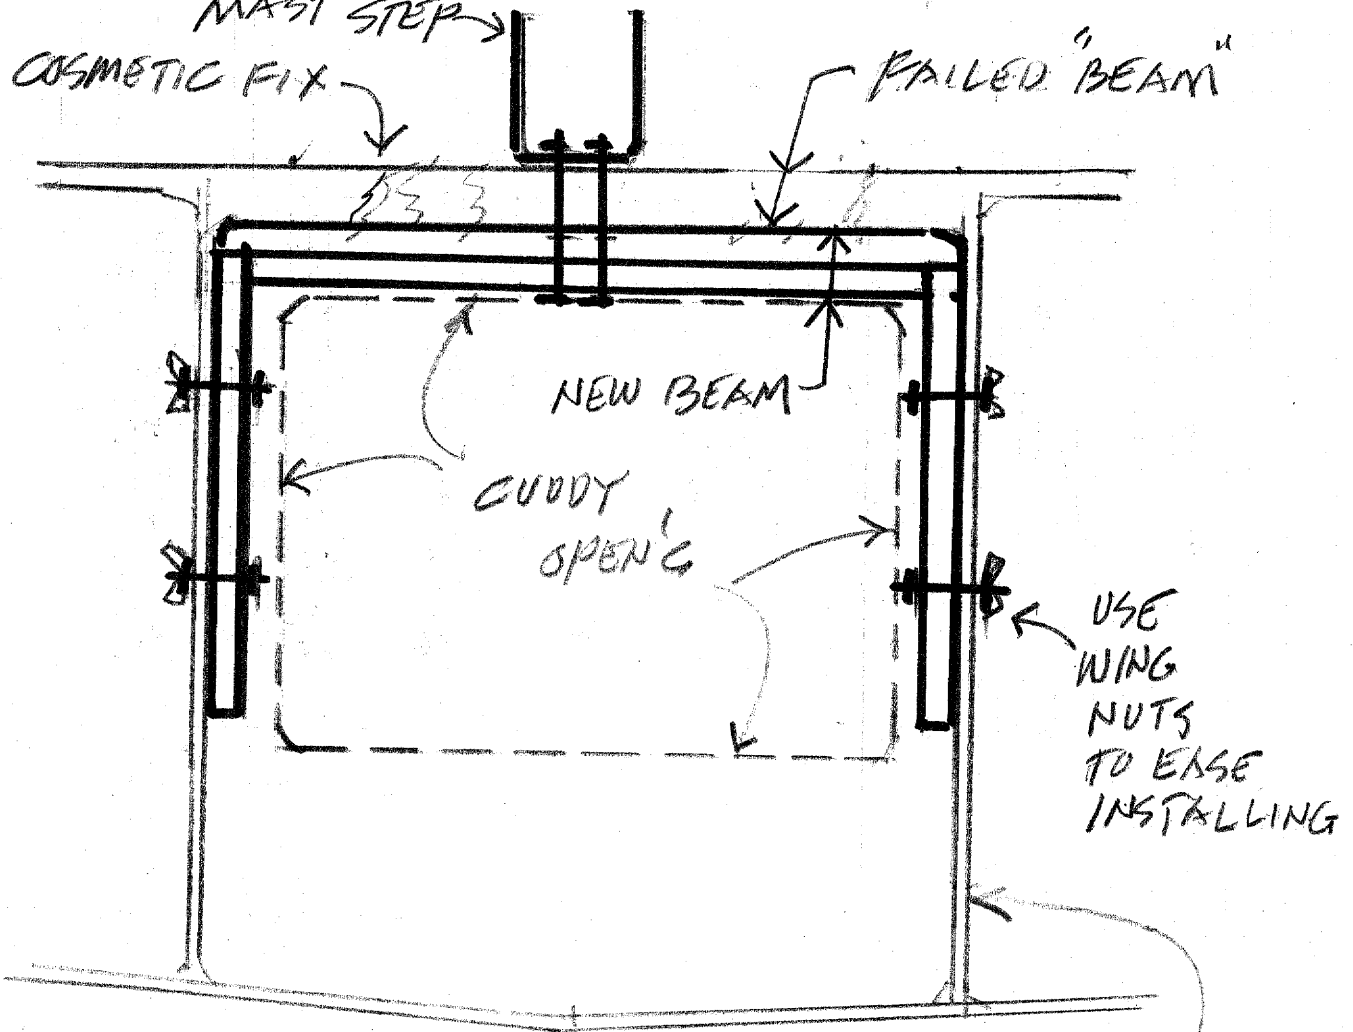
SP 1

FAILED ORIGINAL MAST SUPPORT "BEAM"
IS ABOUT 1.5" THICK x 5" WIDE WRAPPED
IN F.G.

THE VERTICAL SUPPORTS
ARE THIN PLYWOOD WRAPPED
WITH F.G. CLOTH.

DEPENDING ON HOW BAD DAMAGED:
SATURATE WITH EPOXY & FORCE BACK INTO
PLACE OR REMOVE & REPLACE UNDER
MAST STEP
